Manhole Inspection Summary

Manhole # S27G__002MH

Location Address: **10 Scheoder St**

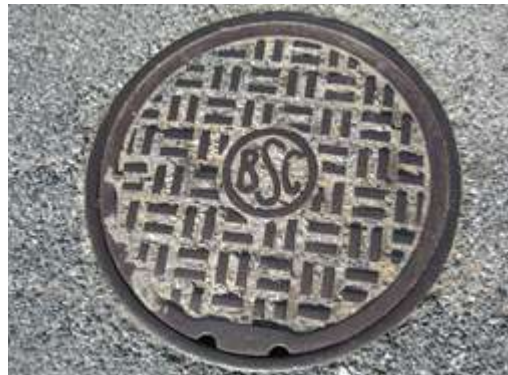
Cover View

Condition: **Sound**

Condition: ☐ Sound ☐ Cracked ☒ **Leaks**

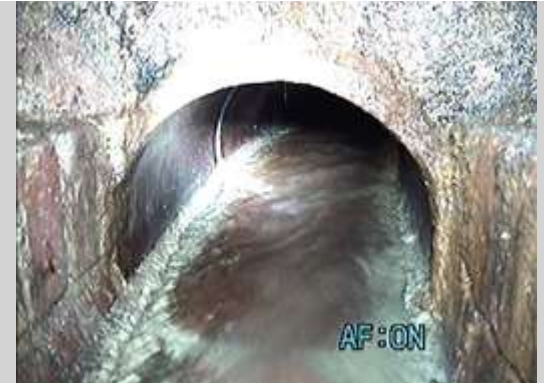
12 O'Clock Outflow

Pipe Height: **10.8** (in.) Rod and Bar (Angled)
Pipe Material: **Clay** ☐ Pipe Lined
Invert Depth: **12.55** (ft.) Flow Characteristics: **Fast**
Deposits: ☒ None ☐ Mud ☐ Sludge ☐ Debris ☐ Grease
Silt Depth: **0** (in.) Deposits Extent:
Infiltration: **None** Pipe Seal Cond: **Sound**

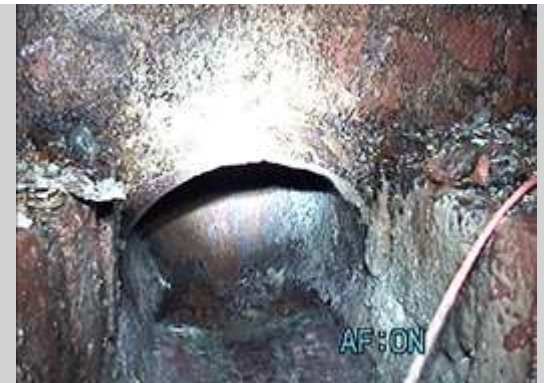
4 O'Clock Inflow

Pipe Height: **7.2** (in.) Rod and Bar (Angled)
Pipe Material: **Clay** ☐ Pipe Lined
Invert Depth: **12.36** (ft.) Flow Characteristics: **Slow**
Deposits: ☒ None ☐ Mud ☐ Sludge ☐ Debris ☐ Grease
Silt Depth: **0** (in.) Deposits Extent:
Infiltration: **None** Pipe Seal Cond: **Sound**
